UPDATE20

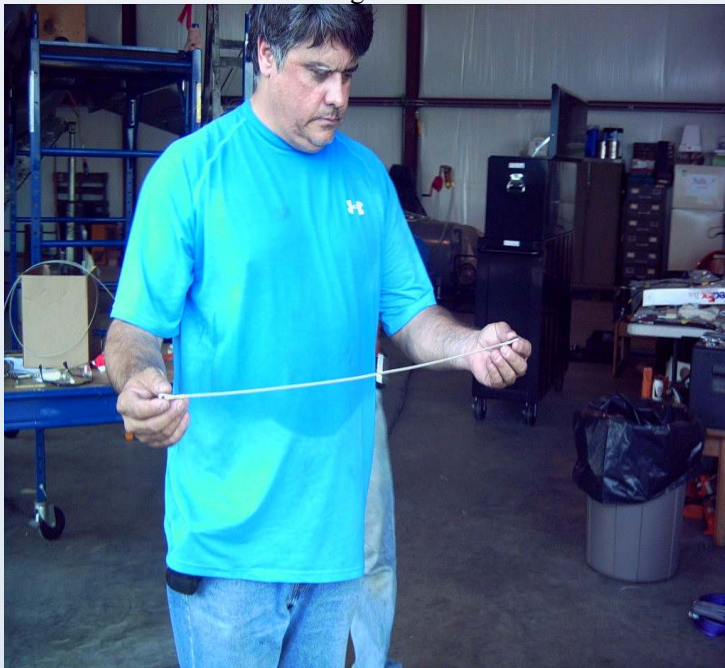
Our test brake cable is ready to be tested.

We located some ends that were close enough and some cable to match and fabricated a test cable. How much force would they need to sustain? There are no statistics in any of our manuals, so we don't even know what standard to test to. So we came up with our own. We needed to improvise.....

There's a photo of our high-precision test rig - a forklift and a tow tractor. Aviation's version of a tractor pull, after all this is Southern Maryland. The tiny cable pulled our tow tractor backwards, and it takes two grown men to push that tractor. Three men, if one of them has forgotten to release the brake. Our test cable is clearly strong enough, but we went further. We tested it to destruction and the cable failed at the fitting. I believe that's more power than I'm capable of applying with my fat foot.

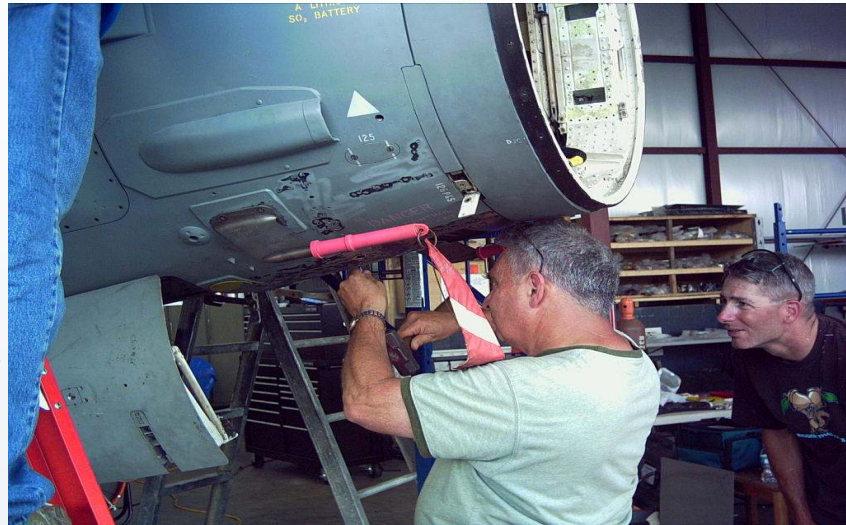
Pete and Mike are removing lots of rivets to make way for a new sheet metal repair.

The following weekend, we reconvened our working party. Our first priority was to complete the sheet metal work under the nose. One of our Marines, who has recently transferred to Quantico, answered the call and had the nose repaired in a day. GySgt Mike Pintha, USMC, 1 each, jumped right in and did a superb job.

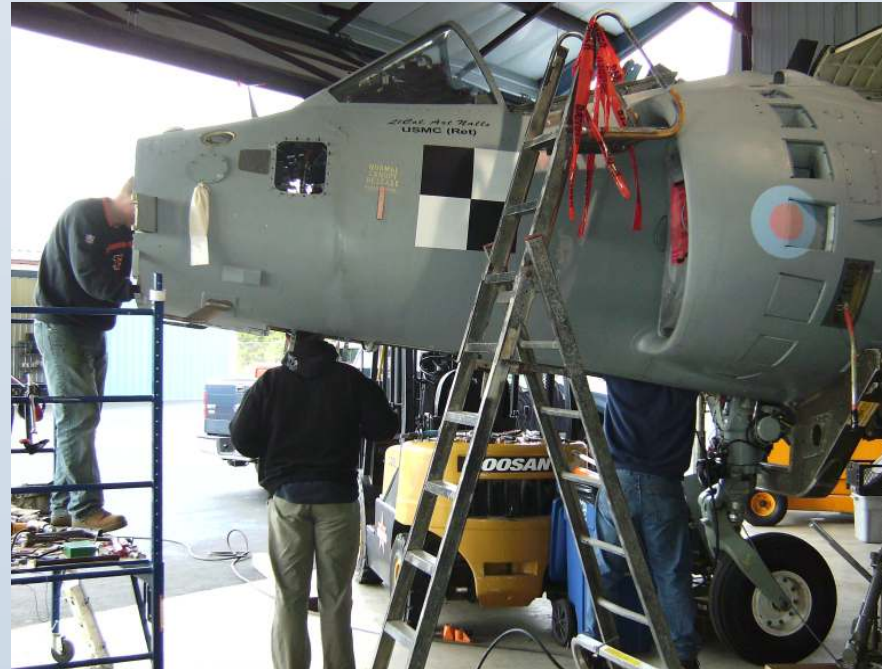
Once the airplane was on jacks, we were able to disassemble the nose and begin our detailed inspections. The reaction controls, nose landing gear doors and all panels were removed.

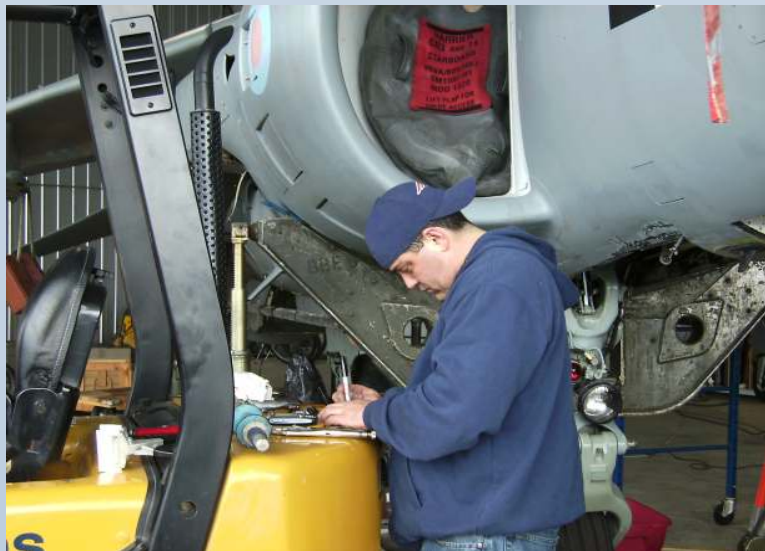
Christian Vlahos is laying out one of several repairs to the inner structure. The forklift is an excellent workbench.

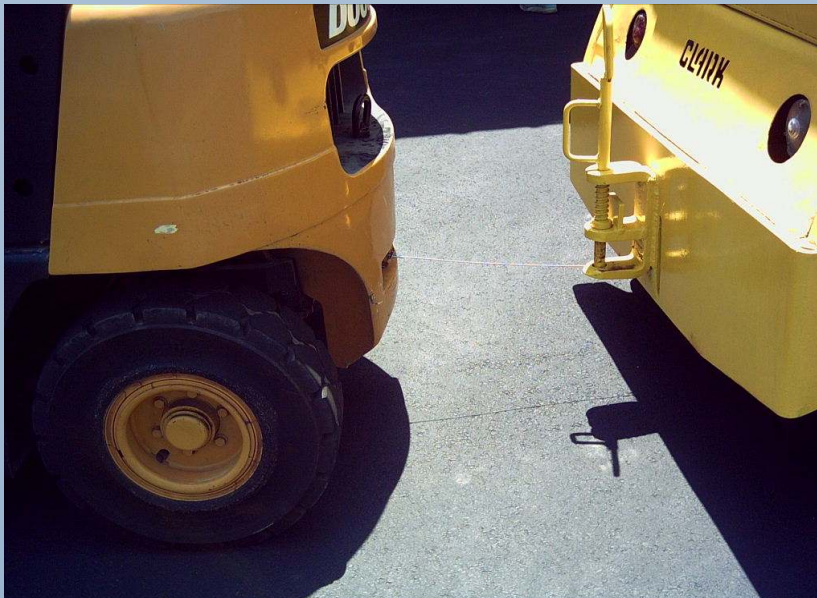
This is our highly-sophisticated, experimental test rig for testing our brake cable.

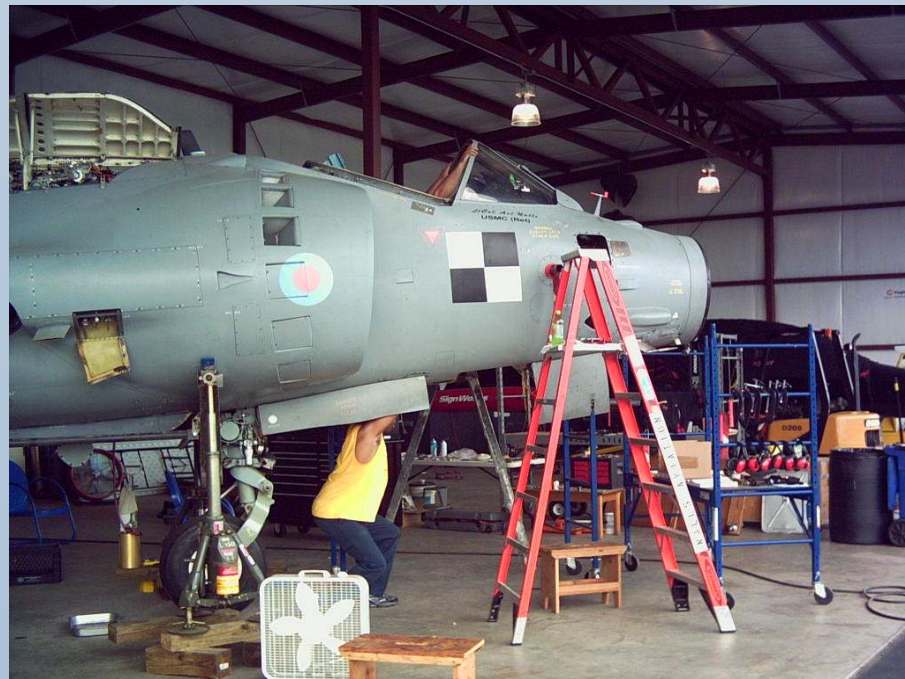
You definitely need extra long arms to get this job done!

A major portion of our reaction control system was removed, inspected, and reinstalled. It's a very tight fit and the fit is critical. We now consider ourselves lucky that our previous hydraulic repairs required 9" fingers and long, skinny arms. For this operation, we needed tiny, tiny fingers to work in between all the hydraulic lines. You can see from one of the photos that some work requires VERY long arms.
